## Casa da Música, Porto, Portugal

**Furtado, R., Oliveira, R., Moás, L.P.**

*AFAssociados – Projectos de Engenharia, SA, Porto, Portugal*

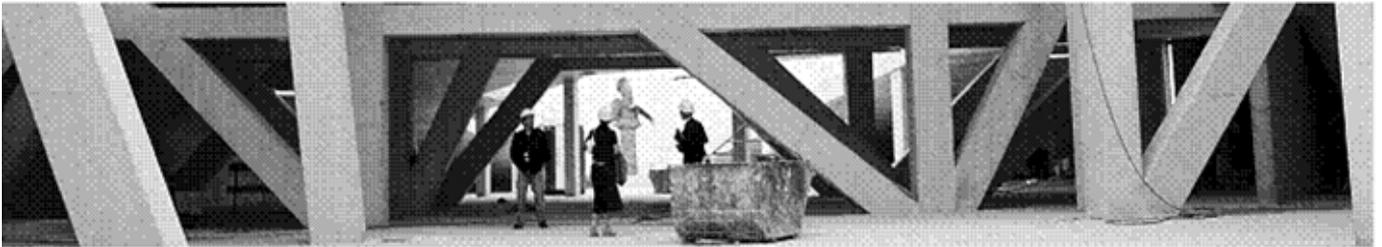
Due to the slight slope of the roof panels, certain free edges which were to be very slender would have had excessive deformations unless the reinforced concrete shell had not been replaced by steel structures comprised of open-web girders or beams in a welded, variable cross section

construction. The rigidity of these edges is crucial in those situations where they support the large glass panels.

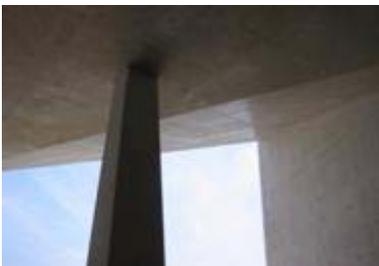
### NORTH ZONE

The extremely complex geometry of the slabs, stairs, ramps and walls of the North side results in several types of structural solutions for supporting the slab loads. In addition to the main longitudinal north wall and the exterior shell, there are also two lift shafts and an inclined pillar, which also act as vertical support elements. When possible, the slabs are directly supported on the vertical elements or on the exterior shell. In the areas where this is not possible, the slabs are supported on beams or wall-beams which are sometimes also supported by other wall-beams.

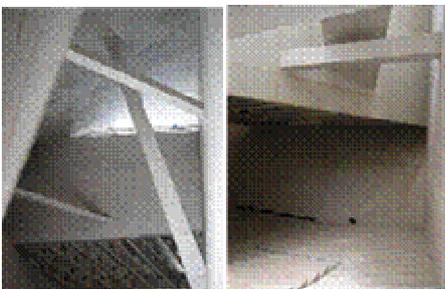
### SOUTH ZONE – FOYER

On the South side there is the large volume of the entrance gallery which is interrupted at its upper part by the small auditorium. Between this gallery and the south longitudinal wall of the auditorium there is also a 7 m wide zone for vertical and horizontal circulation and support spaces. This strip is bounded to the South by a 0,35 m thick reinforced concrete wall with a large number of major openings. The vertical supports for the South side slabs, which in the gallery zone are between the foundations and the access stair level to the main auditorium and in the referred circulation zone up to the roof, is provided by the exterior shell, the main South longitudinal wall, the referred 0,35 m thick wall and also the inclined pillar which intersects the gallery space.

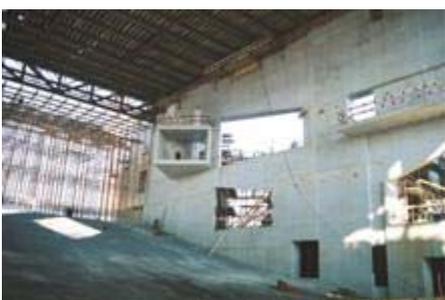
### MAIN AUDITORIUM

The acoustic isolation of the main auditorium is done by means of separating this from the rest of the structure. This separation is referred to as being a “box within a box”. In this separation the floor, walls and ceiling of the auditorium only come into contact with the building’s structure through resilient mounts.

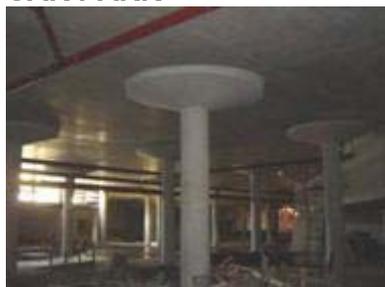
## CAR PARK

The car park layers are massive reinforced concrete slabs. They are supported on isolated pillars, on reinforced concrete walls, on the sloped walls of the auditorium building, and on the peripheral retaining walls.

The columns are circular with truncated conical shear heads and they are generally set out in a 7,8 × 7,8 m<sup>2</sup> grid.

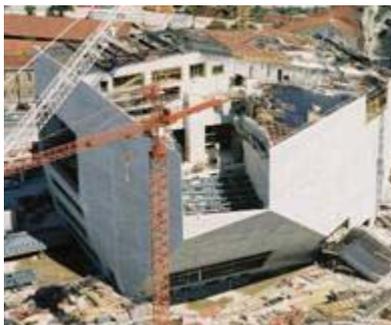
### PHASING OF CONSTRUCTION

The stability of the sloped walls during construction and the fact that the structure would only be stable as a unit, that is, after the conclusion of the entire exterior shell, required a specific study to be made of the phasing of the construction of the entire structure.

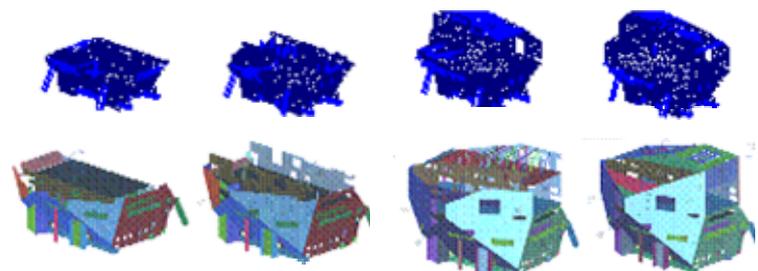
sequence of concreting foreseen, 88 construction phases were defined for the building and the stability of all these phases was studied individually.

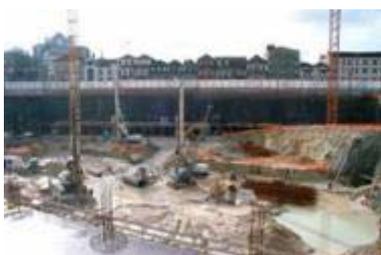
### FOUNDATIONS

In the auditorium building, indirect foundations of piles sunk in slightly altered granite were used. In the car park, footings based in the gravelly layer present at the pillar base level were used.
